Manhole Inspection Summary

Manhole # S150O1011MH

Inspection ☐ Is Incomplete Rating: **4) Poor**

Location Address: **4701 YELLOWWOOD AVE**

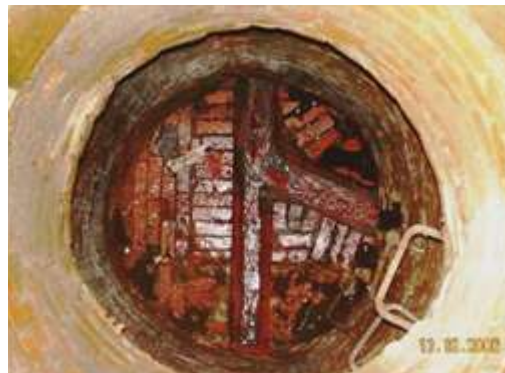
Top View

☒ **Debris** (not Condition related)

Count: **4** Missing: **0** ☒ **Corroded**

Corroded steps. Bench debris.

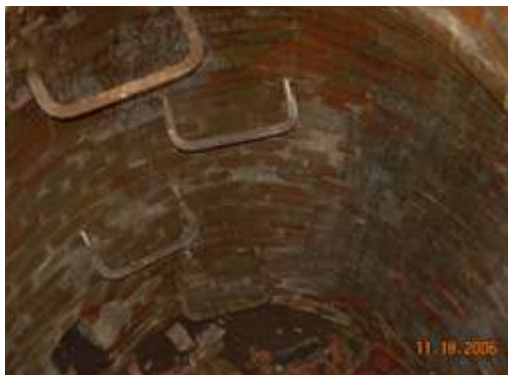
Defect

☒ **Leaks**

Infiltration: ☐ None ☒ **Joint** ☐ Cracks ☒ **Mortar** ☐ Roots ☒ **Wall**

Frame leaks. Adjustment, Corbel and Barrel infiltration - other side.

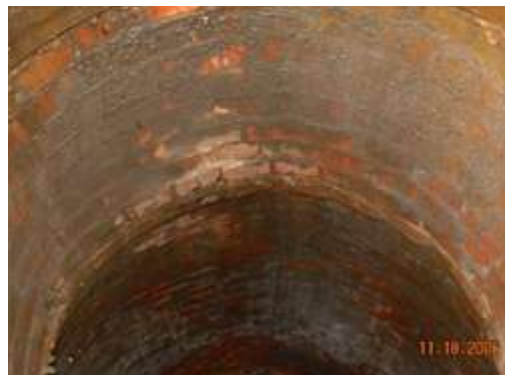
Defect

Frame leaks. Adjustment, Corbel and Barrel infiltration.

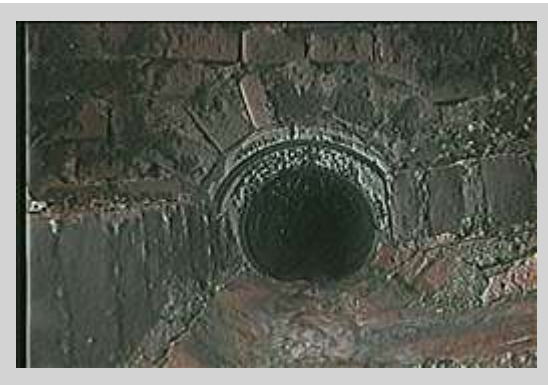
8 in. Circular Gravity Sewer Pipe Out @ 12 O'Clock

Condition: ☐ Sound ☐ Cracked ☐ Root Intrusion ☒ **Deteriorated** ☐ Leaks ☐ Debris

Channel deterioration.

Infiltration: **Evidence** Pipe Seal Cond: **Unknown**

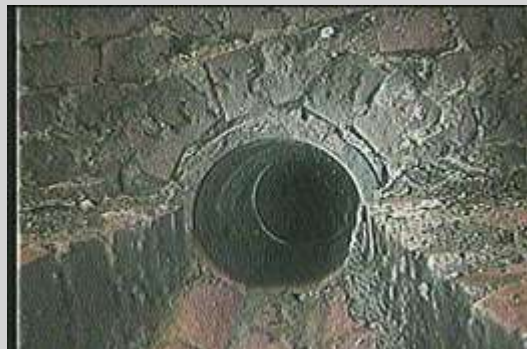
Pipe In @ 6 O'Clock

Condition: ☐ Sound ☐ Cracked ☐ Root Intrusion ☐ Loose Brick ☒ **Deteriorated**

Infiltration: ☐ None ☐ Joint ☐ Cracks ☒ **Mortar** ☐ Roots ☒ **Wall**

Barrel deterioration and infiltration.
